# Mechanical Reliability Testing

MAXMAC evaluates ion modules through combined temperature/vibration, mechanical shock and free-fall testing. This note brings the three methods together with their fixture arrangements, process records, functional checks and physical observations.

The same six sample identifiers, 65#-70#, are retained across the three mechanical tests. Each test received a Pass judgment. The record documents normal function and current, normal appearance and structure, and post-drop LIN, ion-output and shake-check results. Subsequent internal inspection covered samples 69# and 70#.

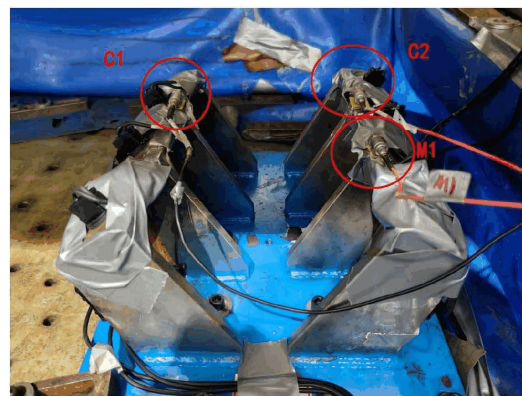
Figure 4 Control points C1/C2 and monitoring point M1 in the original photograph. Control uses the average of two points at the sample/fixture connections.

**Recorded observations:** normal current with no obvious change during testing; no abnormality in appearance or structure afterward. Overall result: **Pass**.

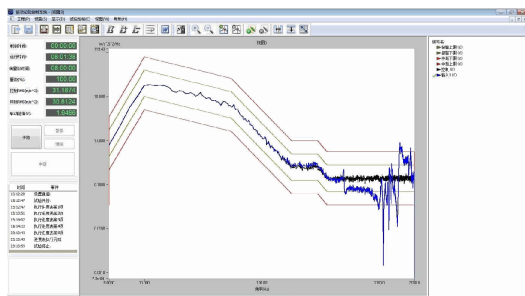
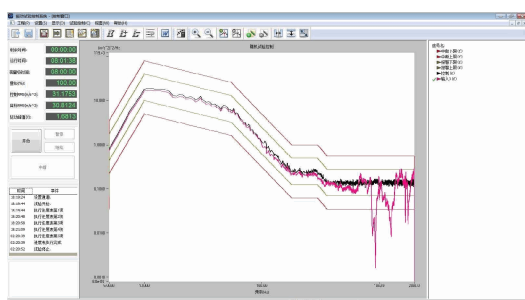
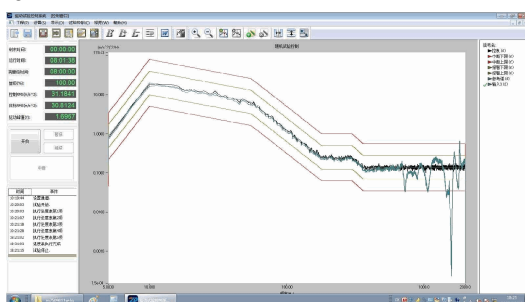
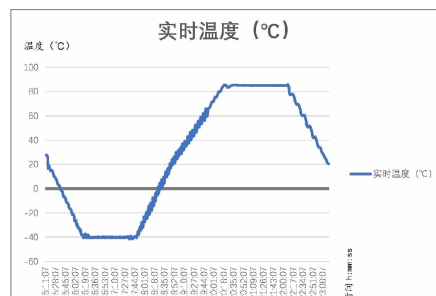
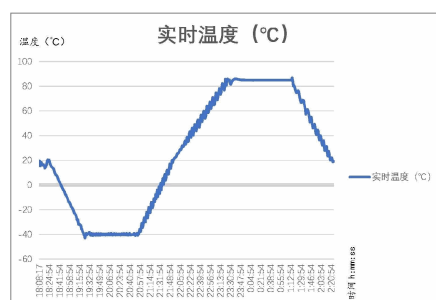
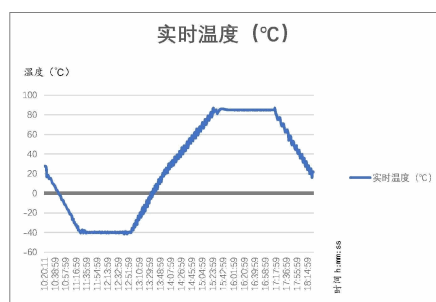
Figure 5 Original X-, Y- and Z-axis spectrum/temperature pairs, source pp. 55, 57 and 59.

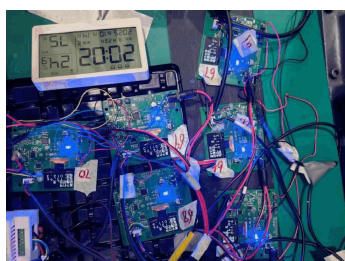
Figure 6 Original monitoring photographs, source pp. 56, 58 and 60. Connected module interfaces and monitoring boards remain in place during the recorded axis tests. The source reports normal current with no obvious change.

Y-axis photo: 1 sample connections; 2 monitoring boards; 3 supply equipment.

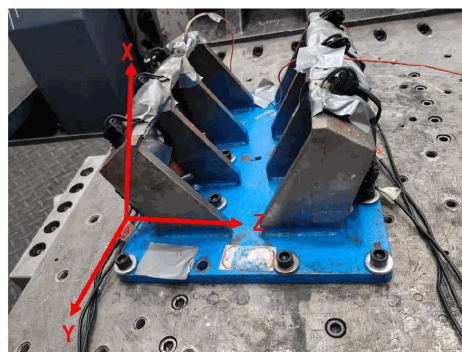
Figure 7 Original mounting arrangement. Modules are fixed to the fixture; the control sensor is near the mounting feet. Connector routing follows the installed arrangement.

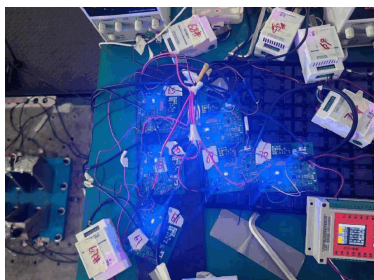
Figure 9 Original connected monitoring arrangement.

The photograph retains the sample-interface connections and functional monitoring boards used during shock testing. The report records **normal current with no obvious change**. After the test, appearance and structure showed no abnormality. The test was judged **Pass**.

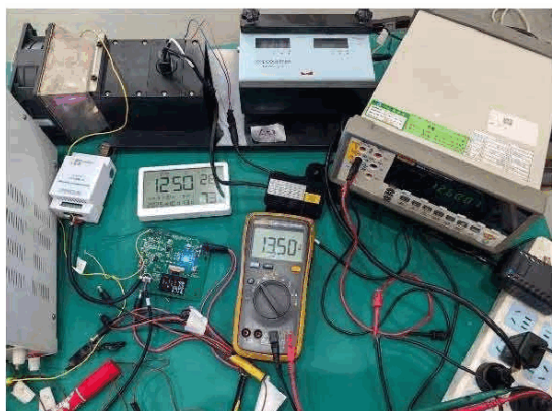
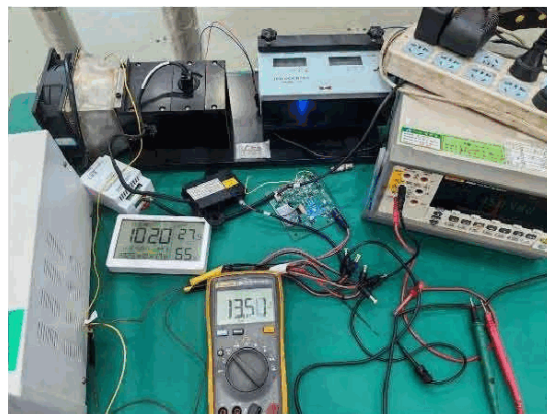
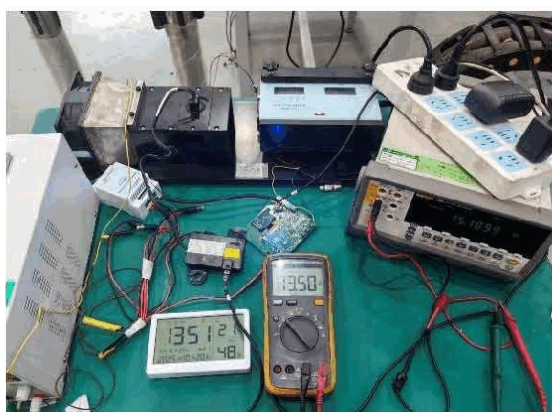
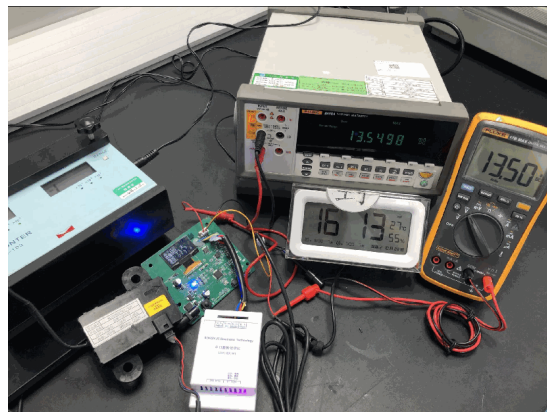
Figure 10 The same sample at four recorded functional checkpoints.

| Sample | Before: current (mA) | After: current (mA) | LIN / ion output | Appearance / shake |
|---|---|---|---|---|
| 65# | 12.6476 | 13.5498 | All pass | Normal / normal |

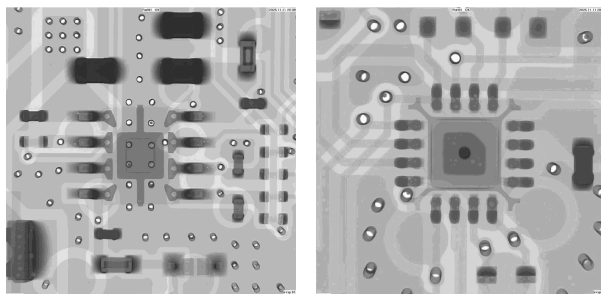
Figure 14 Original X-ray images of both locations on both boards.

| Sample | Position 1: void ratio | Position 2: void ratio | Recorded observation |
|---|---|---|---|
| 69# | 6.7% | 16.1% | No solder-joint cracks or obvious abnormalities. |

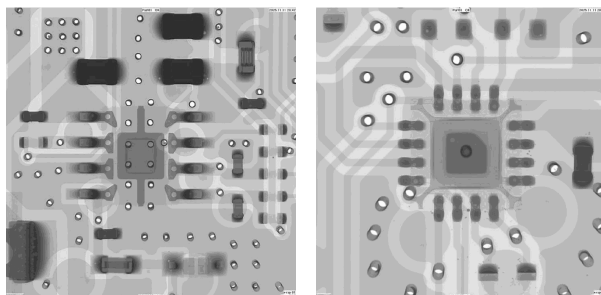
| Sample | Position 1: void ratio | Position 2: void ratio | Recorded observation |
|---|---|---|---|
| 70# | 4.9% | 0.5% | No solder-joint cracks or obvious abnormalities. |
