# High-Temperature Endurance Testing

## Preface

Six modules completed a 1,200-hour program and received a Pass judgment: Class A function, no abnormal appearance and no abnormal internal sound during shaking. This note presents the operating procedure, before-and-after check photographs, and the subsequent X-ray and cross-section inspection records.

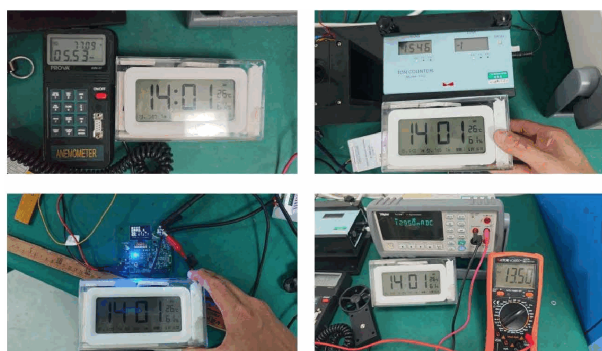
## Sample 7#: Before Endurance

Figure 5 Original pre-test function checks.

Top left: air-speed measurement. Top right: ion counter. Bottom left: functional monitoring. Bottom right: supply and electrical measurement instruments.

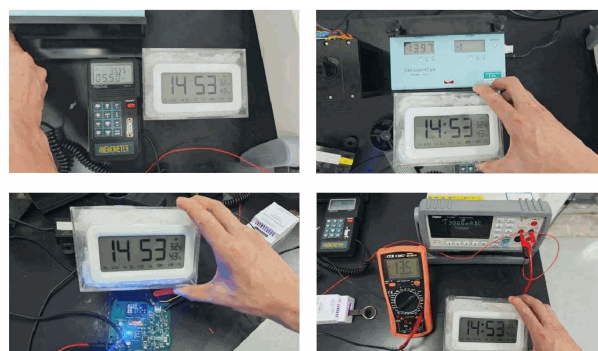
## Sample 7#: After Endurance

Figure 6 Original post-test function checks.

Top left: air-speed measurement. Top right: ion counter. Bottom left: functional monitoring. Bottom right: supply and electrical measurement instruments.

| Check | Recorded result | Original record |
|---|---|---|
| Functional status | Meets Class A | Function photographs, pp. 53-58 |
| Appearance | No abnormality | Result statement, p. 53 |
| Shake check | No abnormal internal sound | Result statement, p. 53 |

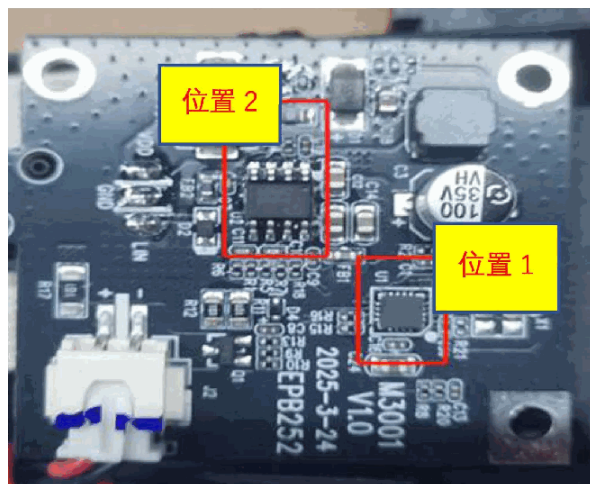
Figure 7 Original board photograph. The marked areas identify Position 1 and Position 2 used in the inspection.

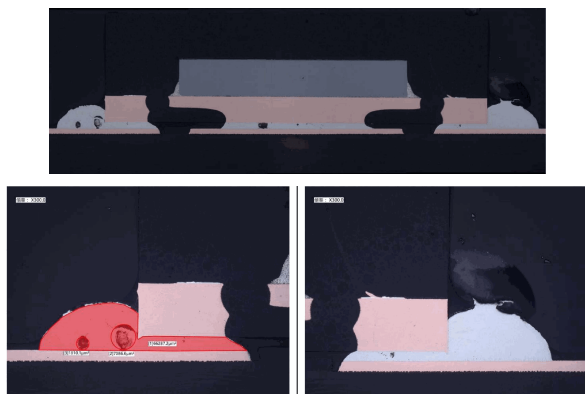
#### Position 1

Overview and detailed microscopic views.

| Inspection board / record ID | Position 1: void ratio | Position 2: void ratio | Recorded observation |
|---|---|---|---|
| 67# / 2508006682-1 | 11.8% | 5.3% | No solder-joint cracks or obvious abnormalities observed. |

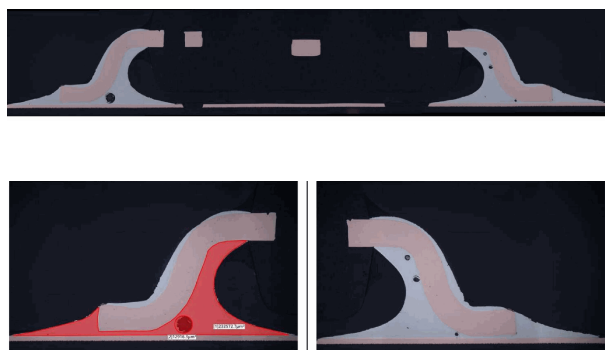
#### Position 2

Overview and detailed microscopic views.

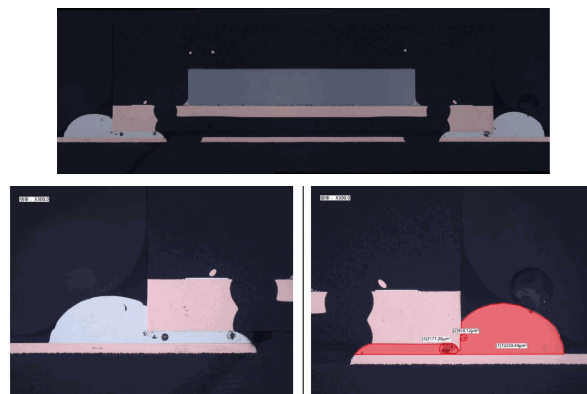
#### Position 1

Overview and detailed microscopic views.

| Inspection board / record ID | Position 1: void ratio | Position 2: void ratio | Recorded observation |
|---|---|---|---|
| 68# / 2508006682-2 | 3.5% | 5.5% | No solder-joint cracks or obvious abnormalities observed. |

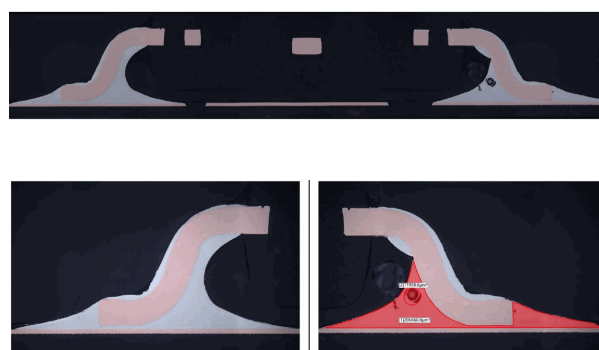
Overview and detailed microscopic views.
