# Steady-State Damp-Heat Testing

MAXMAC evaluates ion-module function under sustained high temperature and humidity. The procedure specifies a constant chamber condition, a repeated operating-mode schedule and functional inspection after natural recovery to room temperature.

Six modules completed the 10-day damp-heat program at  $65 \pm 2^\circ\text{C}$  and  $93 \pm 3\%$  RH. The report records Class A function before, during and after testing, with no visible damage or the listed internal-board abnormalities. The overall judgment was Pass.

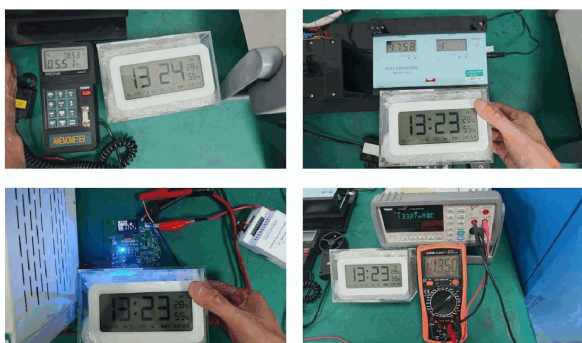
Figure 5 Original pre-test functional checks.

Air-speed meter and ion counter above; functional monitoring and electrical measurement instruments below.

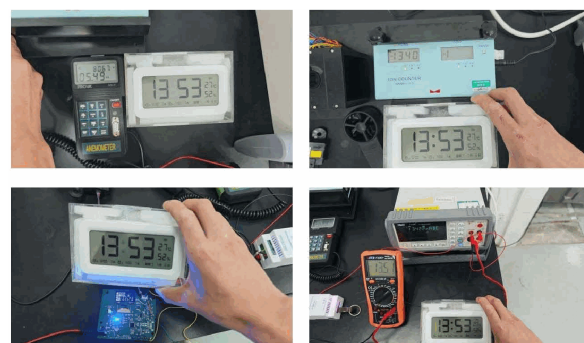
Figure 6 Original post-test functional checks.

Air-speed meter and ion counter above; functional monitoring and electrical measurement instruments below.
