# Temperature-Cycling Endurance Testing

MAXMAC evaluates ion modules through repeated powered temperature cycles between  $-40^{\circ}\text{C}$  and  $+85^{\circ}\text{C}$ . The procedure defines the temperature ramp, hold time, operating modes and recovery steps, with electrical and ion-output checks linked to the sample record.

Six modules completed 385 cycles and met the Class A requirement after testing. Recorded checks cover working current, standby current, LIN communication, ion output and appearance. Subsequent X-ray and cross-section records document two inspected boards.

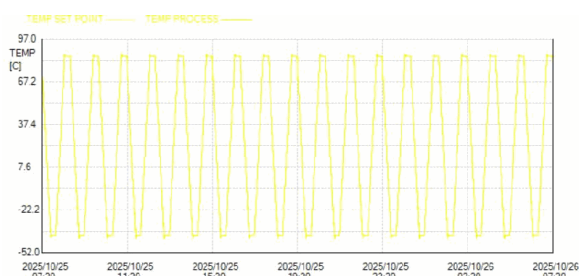
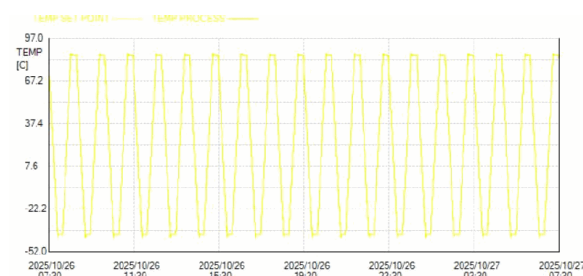
*Figure 5 Six original chamber-curve windows spanning the start, middle and end of the recorded program.*

The original plots display repeated temperature changes across the specified cold and hot limits. The selected windows retain their recorded timestamps and the setpoint/process trace labels. Current and LIN measurements are listed separately in the stage-results table.

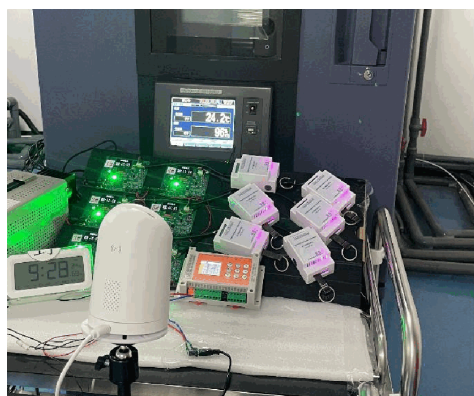
*Figure 6 Original monitoring and connection arrangement outside the chamber.*
