# High-Temperature Endurance Testing

## Preface

Six modules completed a 1,200-hour program and received a Pass judgment: Class A function, no abnormal appearance and no abnormal internal sound during shaking. This note presents the operating procedure, before-and-after check photographs, and the subsequent X-ray and cross-section inspection records.

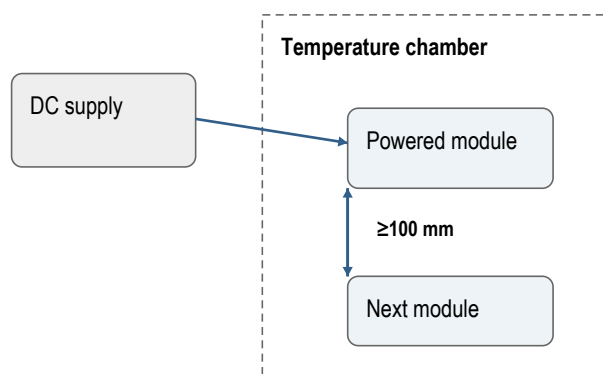
Figure 2 Powered arrangement and specified clearances.

Place the modules in the chamber with  $\geq 100 \text{ mm}$  between samples and  $\geq 100 \text{ mm}$  from chamber walls.

Also  $\geq 100 \text{ mm}$  from chamber walls

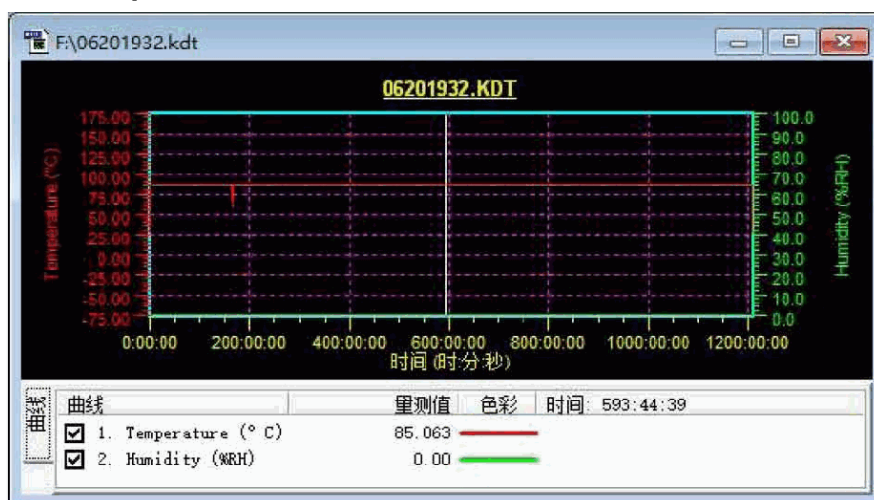
Figure 4 Original temperature-versus-time record. The horizontal axis extends to 1,200 hours; the red trace records chamber temperature during the high-temperature program.
