# Mechanical Reliability Testing

MAXMAC evaluates ion modules through combined temperature/vibration, mechanical shock and free-fall testing. This note brings the three methods together with their fixture arrangements, process records, functional checks and physical observations.

The same six sample identifiers, 65#-70#, are retained across the three mechanical tests. Each test received a Pass judgment. The record documents normal function and current, normal appearance and structure, and post-drop LIN, ion-output and shake-check results. Subsequent internal inspection covered samples 69# and 70#.

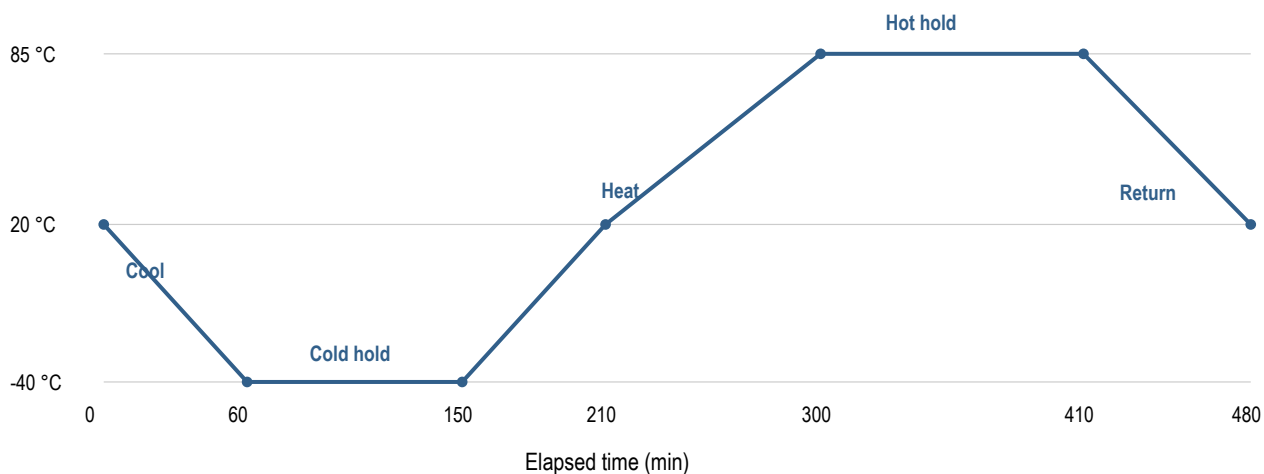
Figure 3 Programmed profile reconstructed from the recorded time-temperature nodes on source p. 50.

**Cold hold:** 150 – 60 = 90 min. **Hot hold:** 410 – 300 = 110 min.  
**Per axis:** 480 min = 8 h. **Three axes:** 3 × 8 h = 24 h.
